Stuart Tappin

Dudley Zoological Gardens

Dudley, England | 1937

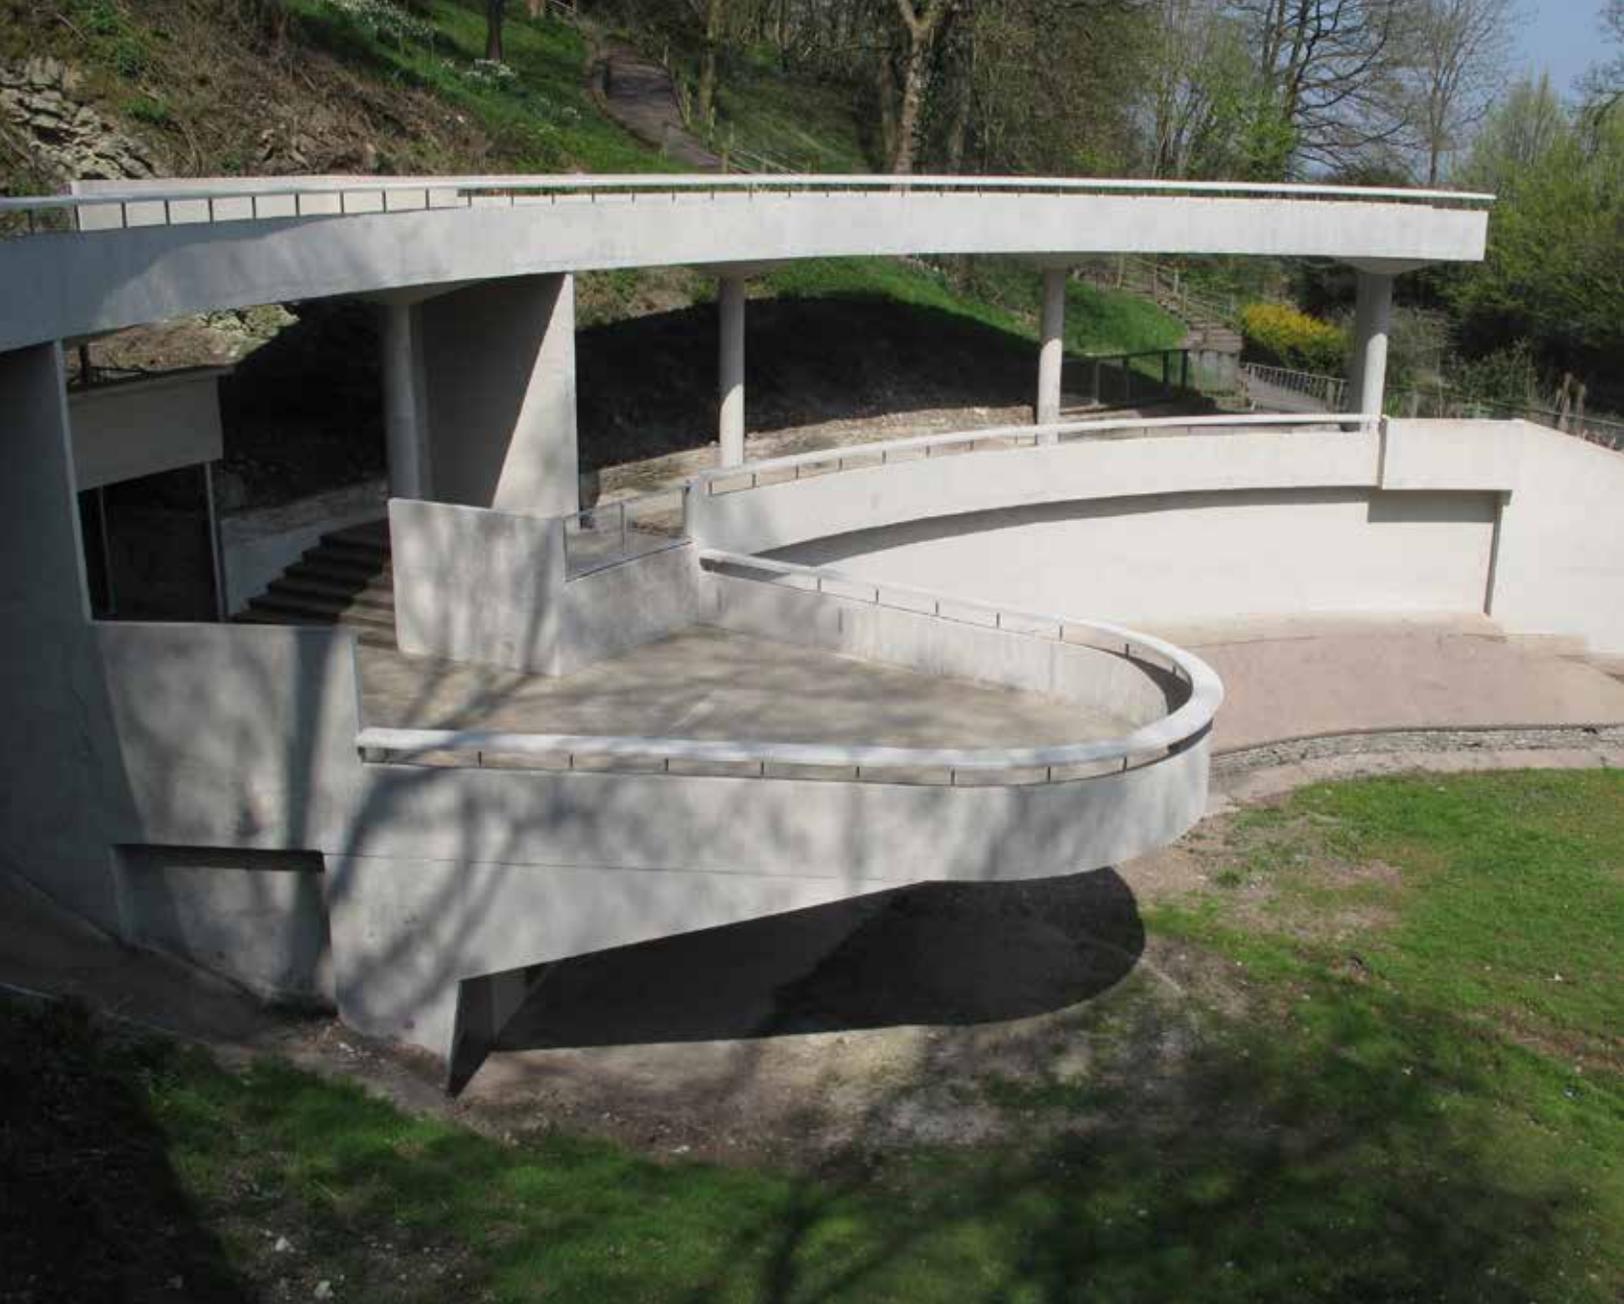
Fig. 4.1. Dudley Zoological Gardens. The repaired bear ravine, 2015.

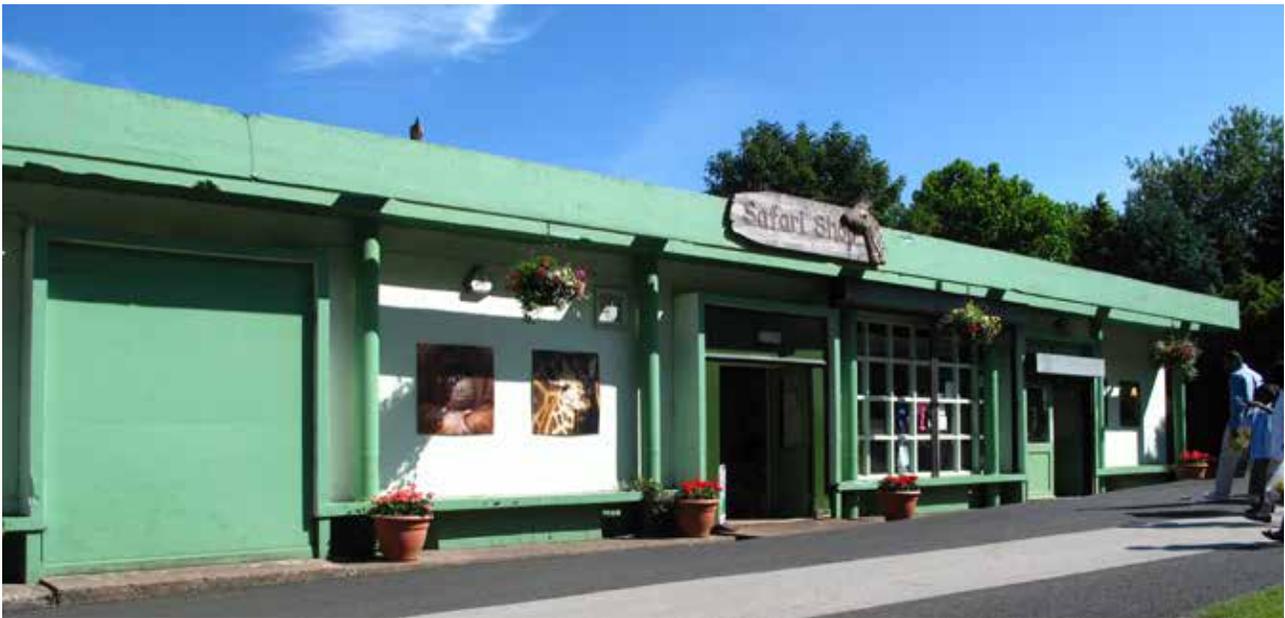
nightclub, and finally the zoo’s souvenir shop. The original open, windowless pavilion style of the building had been lost amid the changes and clutter, and partitions had been installed enclosing sections of the building for storage. Other areas were simply abandoned. The proposal was to remove all of the later additions and reinstate the open layout. In accordance with the wider master plan for the zoo, the shop was to provide a proper entrance for visitors and an interpretation space to explain the history of the zoo and its buildings (fig. 4.3).

Fig. 4.3. The shop before the works, 2011

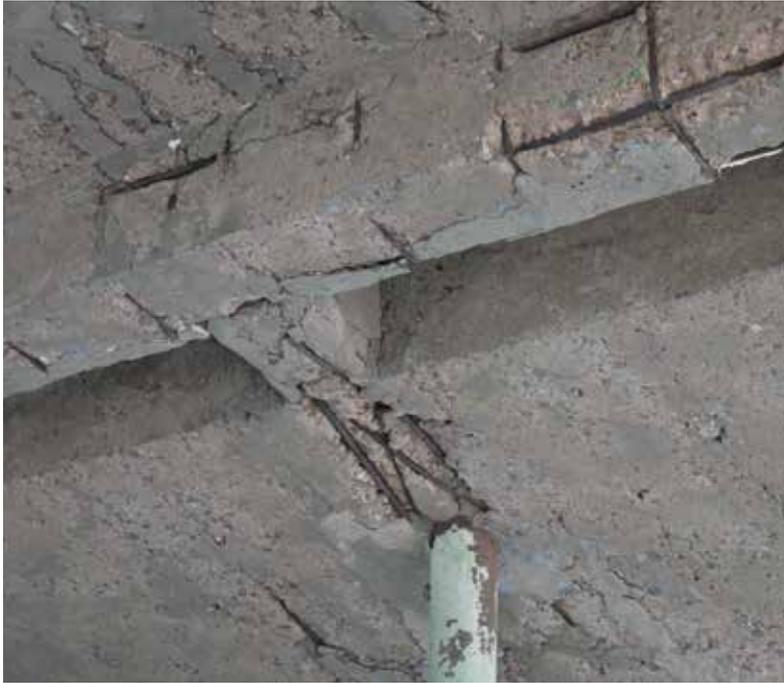
Fig. 4.4. A typical area of damage to the underside of one of the entrance canopy slabs, 2012

There is little information from the 1930s about how reinforcement was to be supported during concreting. One contemporary reference, in *Cassell's Reinforced Concrete*, mentions the use of notched timber templates that “can be removed shortly after the concreting has begun, quite a small quantity of concrete sufficing to hold the rods in place” (Jones and Lakeman 1920, 140). If this was the method used here, then the undulating shape of the slabs meant it was almost inevitable that the bars would slump toward the bottom of the wet concrete and rest on the shuttering. We can only surmise that the pressure to open the zoo to the public led to a make-do approach, with a render coat and paint applied to hide the exposed reinforcement (fig. 4.4).

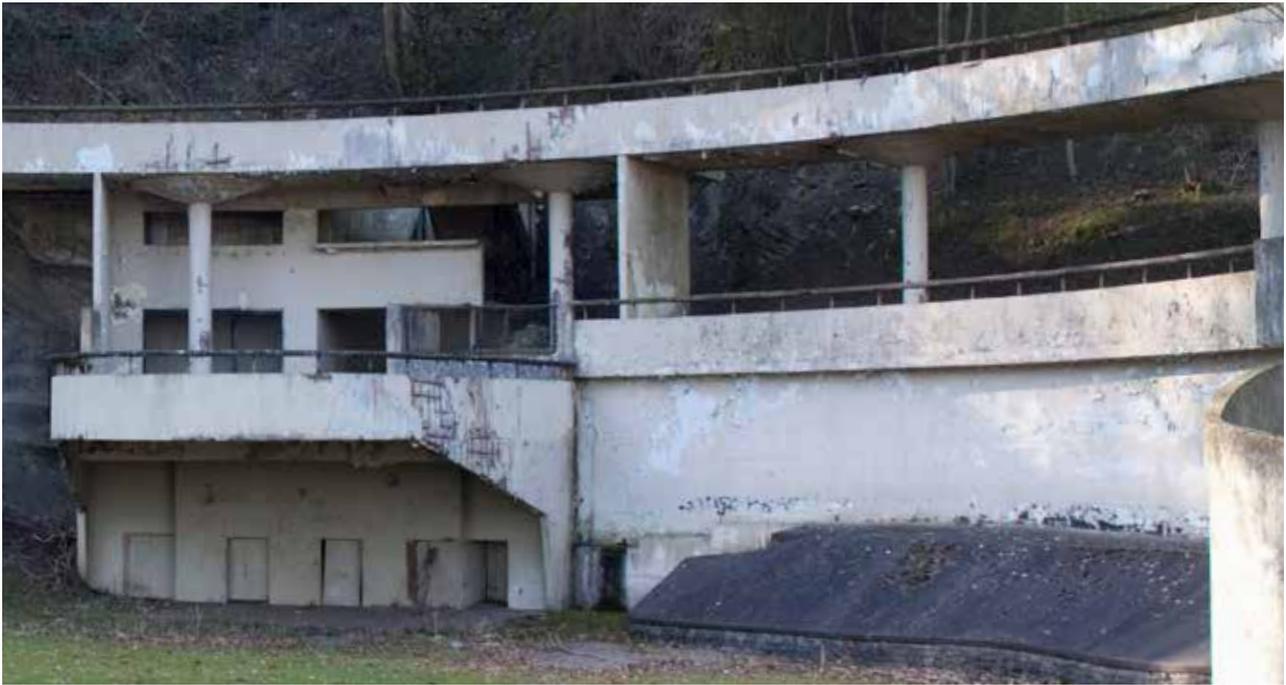
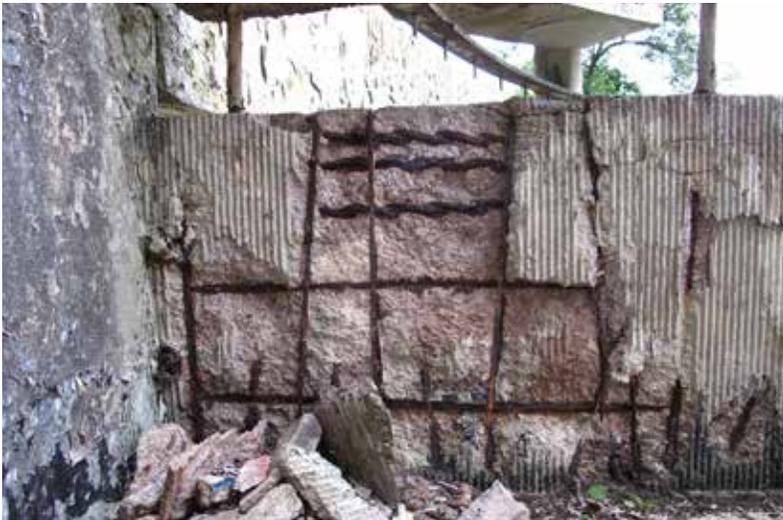
Fig. 4.5. The bear ravine prior to repairs, 2011. Photo: Tony Hisgett / Courtesy Wikimedia Commons, CC-BY-2.0

Fig. 4.6. Detail of the bear ravine prior to the works, 2012

cantilevered viewing platform there were large areas on both faces of the parapet where the concrete had fallen away and exposed the corroded reinforcement behind. The extent of corrosion to some of the circular hollow steel columns around the stairwell to the upper viewing level was of sufficient concern to prompt immediate installation of temporary props (figs. 4.5, 4.6).

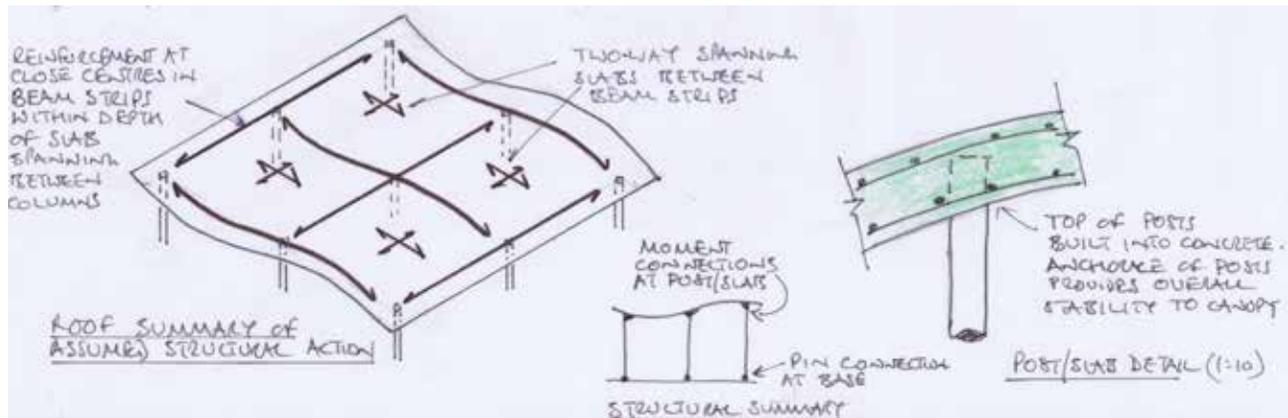
Fig. 4.7. Structural summary of entrance roofs

The entrance to the zoo is formed of five undulating reinforced concrete slabs above individual ticket kiosks that are built of brickwork and timber. Each roof slab is 6% in. (175 mm) thick and approximately 275 by 275 in. (7 by 7 m) on plan. The slabs have a projecting edge beam on three sides that prevents rainwater runoff from staining the outside edges. The slabs are supported on nine solid steel posts, each 3½ in. (90 mm) in diameter, on a grid of 118 by 118 in. (3 by 3 m). The posts bear onto shallow concrete pad foundations. Two layers of ½ in. (12.7 mm) plain round bars that were observed close to the surface of the soffit indicated that they were designed as two-way spanning slabs. The overall stability is provided by a moment connection between the head of the columns and the slab. The entrance is on sloping ground, and the design cleverly exploits this by having the end of one slab overlapping the next. At each overlap, the three edge columns pass through the lower slab and into the slab above, a detail that provides an additional restraint against lateral movements. This is summarized on the extract from drawing number EC 01 (fig. 4.7).

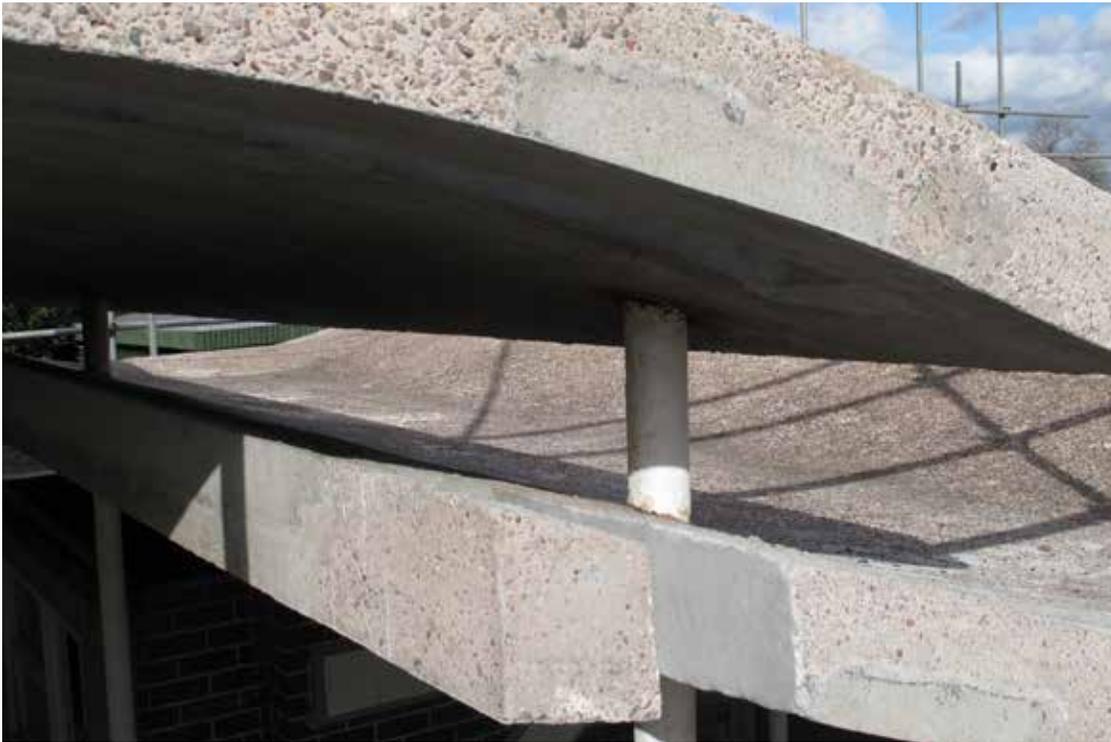
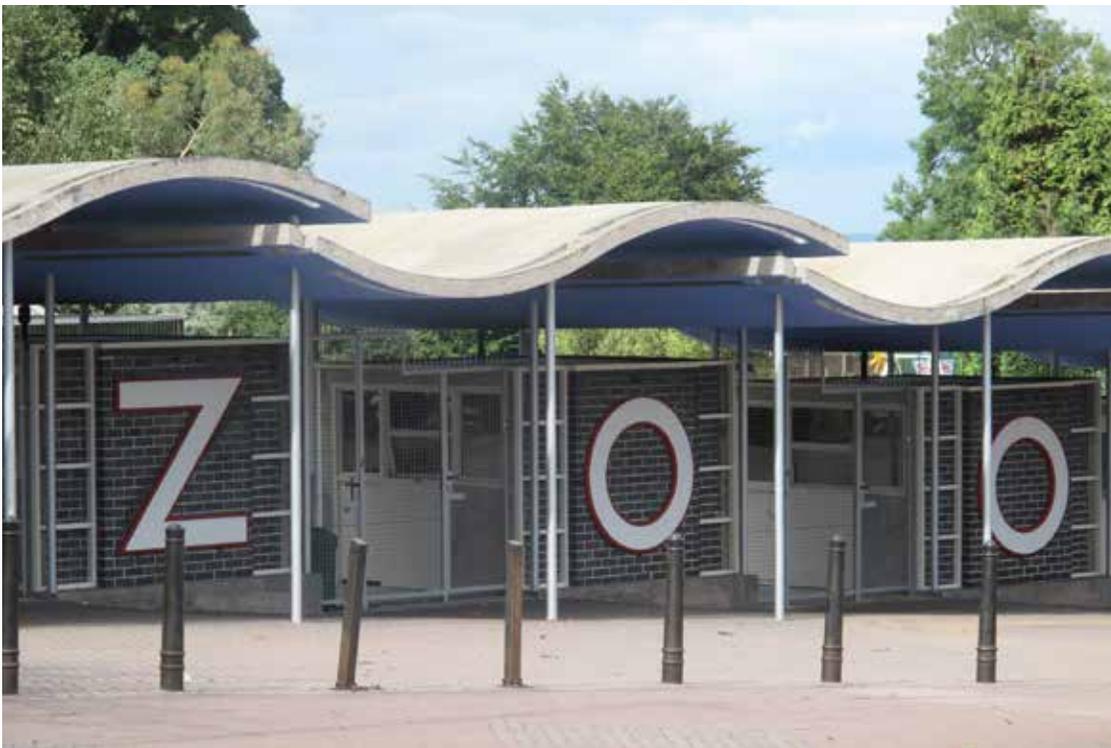
Fig. 4.8. Repair to the entrance canopy slab, 2014

Fig. 4.9. The entrance following conservation work, 2015

A roof covering was therefore proposed and the design criteria included the need to be reversible and to accommodate thermal movements. It also needed to be visually acceptable, as the roof of the entrance building can be seen from the top of Castle Hill and nearby the chair lift. No flashings or mechanical fixings could be used, as this would impact on the slender edge detail of the wave forms. With the exposed location of the entrance, the new covering would also need to resist uplift pressures. Through discussions with the project team and agreement with the local conservation officer and English Heritage (now Historic England), a liquid applied membrane was selected. Resin-set quartz was then applied to the top to match the surface color and texture of the existing concrete. The aggregate for the quartz was sourced from a local quarry to match the tone and consistency of the concrete. The resulting view from the chair lift is of five seemingly untreated concrete canopies (figs. 4.8, 4.9).

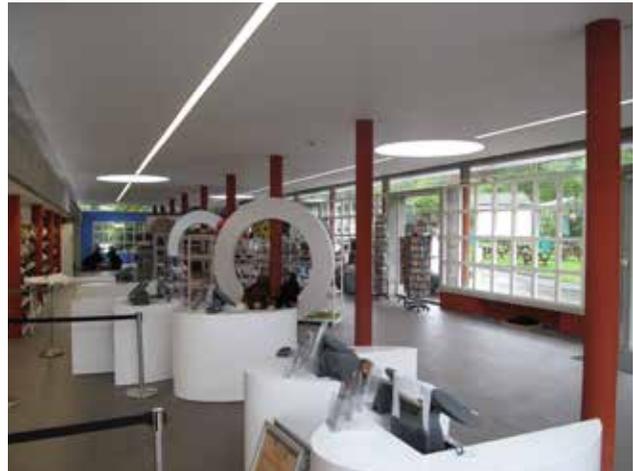
Fig. 4.10. The shop interior after the works, 2014

At the souvenir shop, the initial work involved the stripping out of all the internal fixtures and fittings and the removal of the external roof finishes. Once completed, we found that the concrete roof structure was in much better condition than had been expected and only required a few local patch repairs. A single-ply membrane was installed as a waterproofing barrier atop new insulation. The infilled circular roof lights were reopened. Combined with the removal of the non-original brickwork above the timber window frames, this completely changed the feeling of the internal space, flooding it once again with natural light (fig. 4.10).

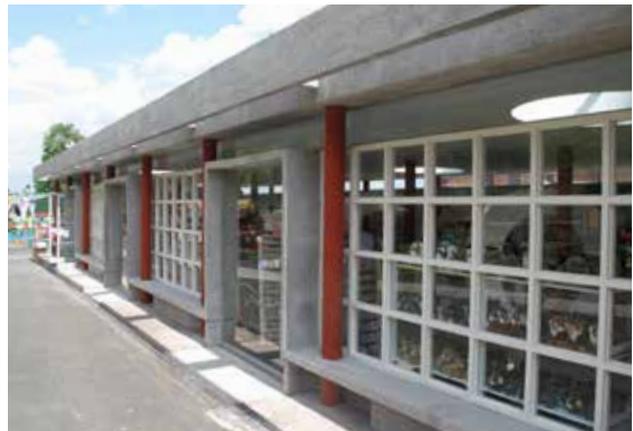
Fig. 4.11. The shop upon completion of repairs, 2014

The works to the entrance and shop were substantially completed on schedule and both opened in time for Easter 2014, to much acclaim (fig. 4.11). The zoo now knew how much money was left for the works to the bear ravine and kiosk. Of equal importance, the design team had tested

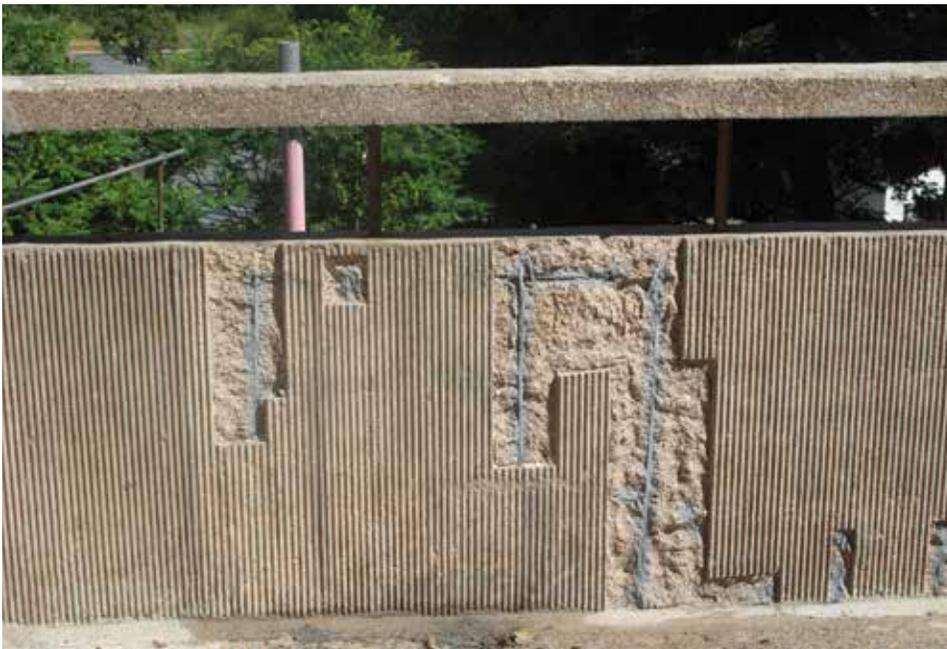
In contrast to the entrance and shop, much of the concrete surface to the bear ravine has a delicate corrugated finish (fig. 4.12). To avoid damage from abrasive cleaning, other techniques to remove debris and paint were tested; at the end of the trials, a two-stage approach was agreed. A ThermaTech superheated steam system was used to remove all organic contaminants and the majority of the coatings. Coatings that were more stubborn were treated with chemical strippers and carefully removed by hand. Areas that did not respond to this treatment were cleaned using a very

Fig. 4.12. Detail of damaged concrete to the bear ravine's parapet during repairs, 2014

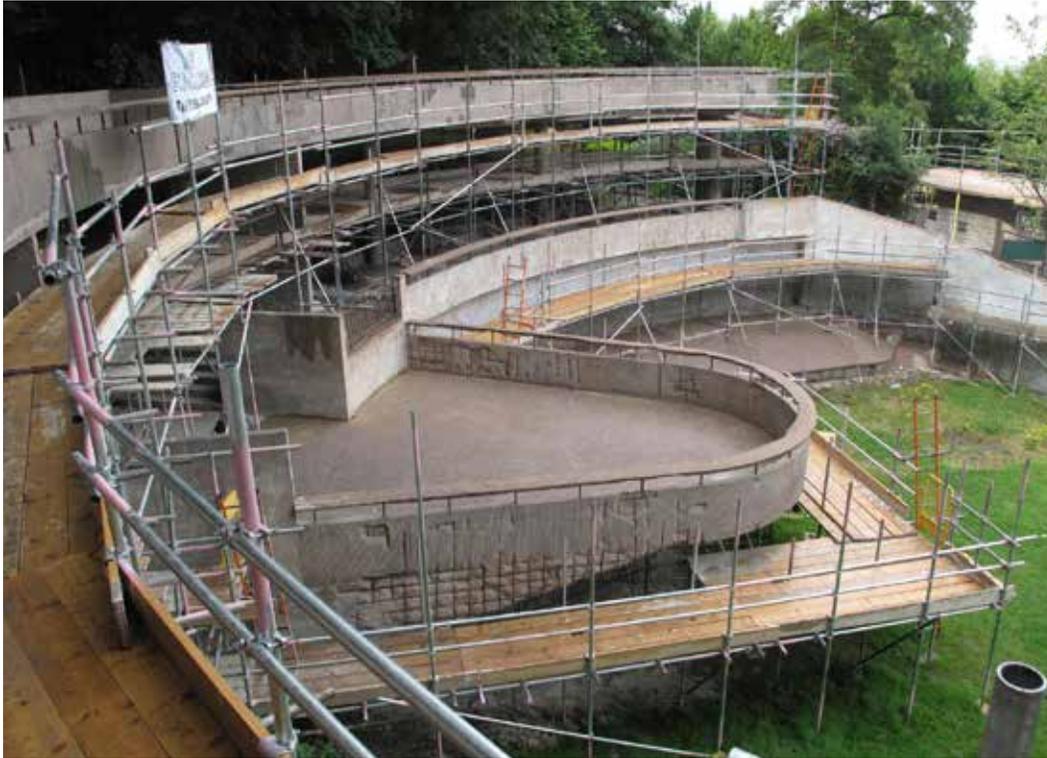
Fig. 4.13. Bear ravine during the repair works, 2014

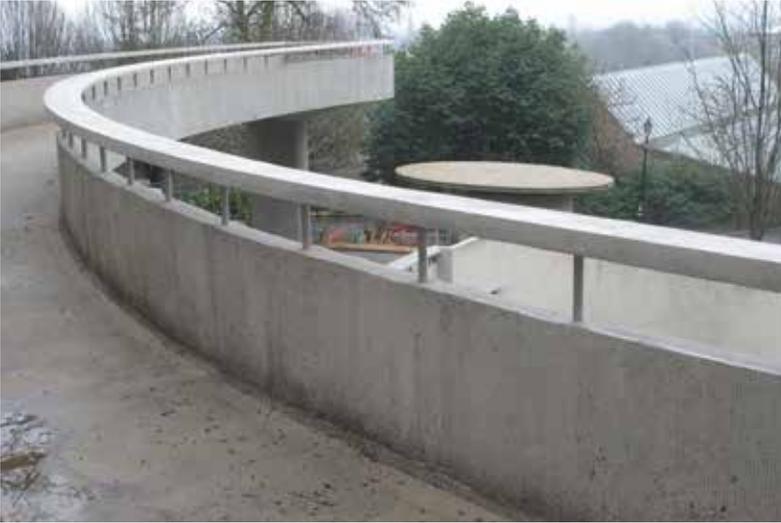
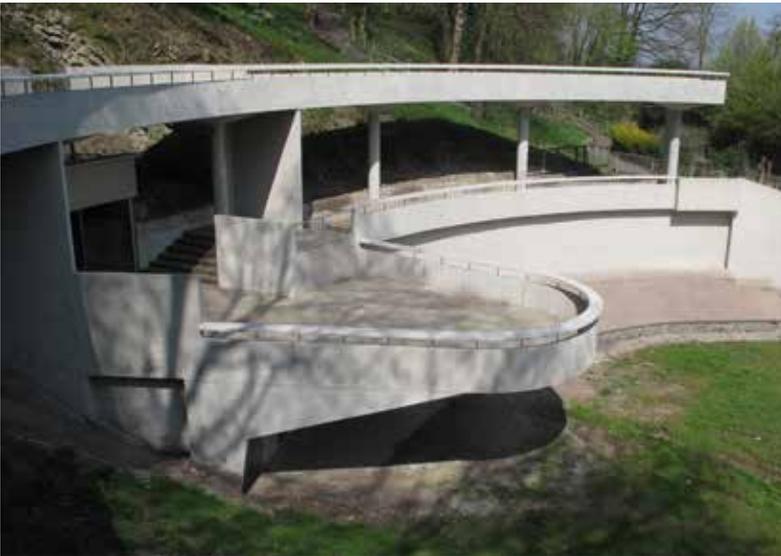
Fig. 4.14. Bear ravine after the repair works, 2015

Fig. 4.15. The repaired bear ravine, 2015

The concrete repairs to the bear ravine, though on a much larger scale than those undertaken on the other buildings, followed the same philosophy. Cement and aggregate mixes were used on all vertical and horizontal surfaces and the polymer-modified repair mortar was used for the undersides of the slabs. The quality of the repairs to the corrugated finish of the parapet walls was a significant achievement by the on-site team. A series of tools were developed, ranging from a float profiled by a latex mold taken from an original section of corrugated metal shuttering to a bespoke timber profiled float. The most useful tool turned out to be a simple round timber dowel that was used to line the profiles through. When breaking out the damaged concrete any sound surfaces were left in place, no matter how small. These areas ensured that the rhythm of the corrugation matched the existing pattern (figs. 4.14, 4.15).

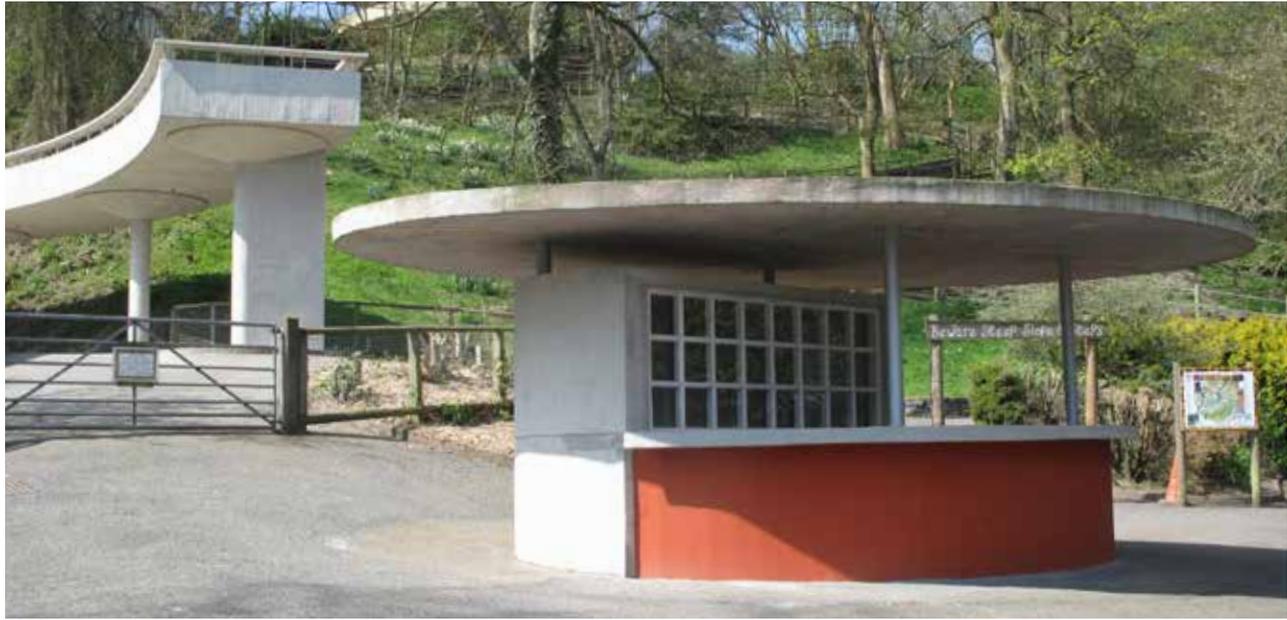
Fig. 4.16. The kiosk with bear ravine behind, following repair works, 2016

The structural repairs to the nearby kiosk were relatively minor. The hollow steel columns had all corroded at the base, which meant that the support to the roof relied on friction where the columns passed through the reinforced

concrete slab that formed the counter to the kiosk. Temporary props were installed before the permanent repair of steel sleeves were welded around the base of each post to reinstate the original support (fig. 4.16).
